**Flood Control Project Maintenance
Levee Inspections**

Fall 2011 Levee Maintenance Deficiency Summary Report

Sacramento River Basin

Sutter Maintenance Yard East-West Interceptor

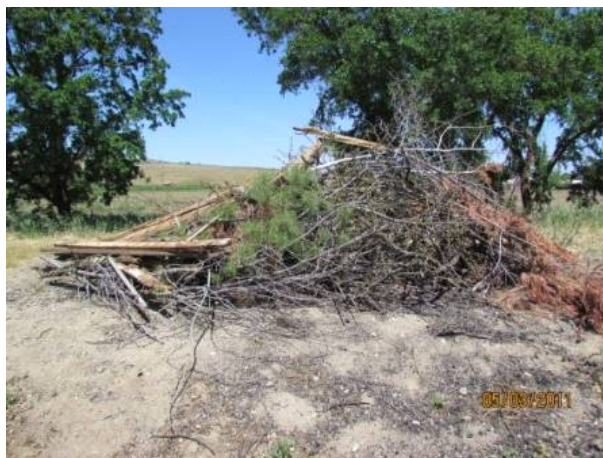
Levee Mile Report Line	1
Start Levee Mile	0.22
End Levee Mile	0.22
Location	Land Side
Category	Earthen Levee
Item	Encroachments

View of the pruning along the levee.

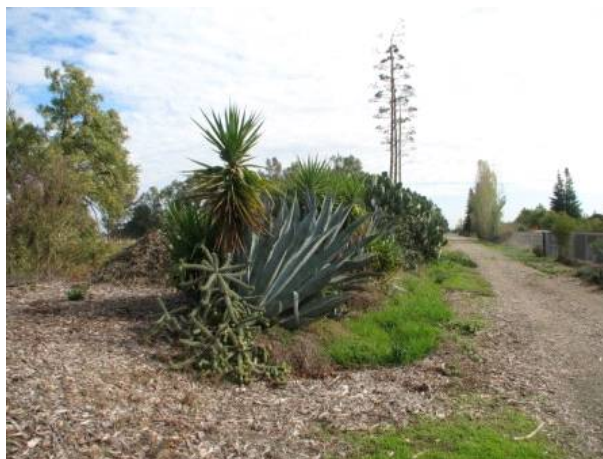
Levee Mile Report Line	2
Start Levee Mile	0.23
End Levee Mile	0.25
Location	Crown
Category	Earthen Levee
Item	Encroachments

View of cactus and pine trees along the land side toe.

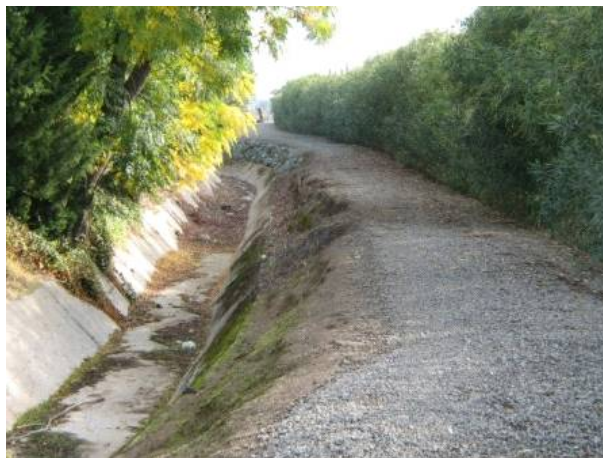
Levee Mile Report Line	3
Start Levee Mile	0.62
End Levee Mile	0.65
Location	Water Side
Category	Earthen Levee
Item	Erosion / Bank Caving

View of the erosion along the concrete ditch on the waterside slope.

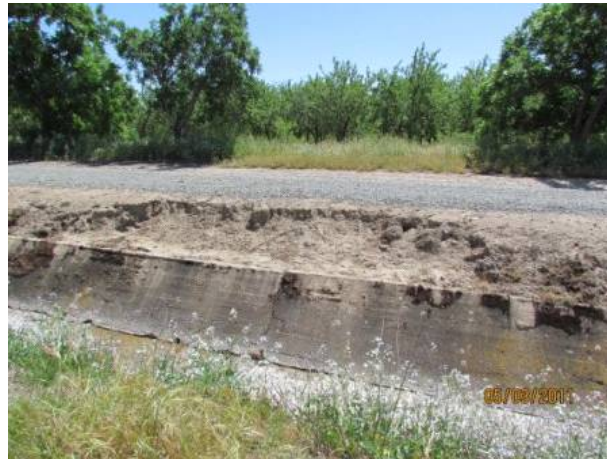
Levee Mile Report Line	4
Start Levee Mile	1.23
End Levee Mile	1.24
Location	Water Side
Category	Earthen Levee
Item	Erosion / Bank Caving

View of the erosion along the concrete canal.

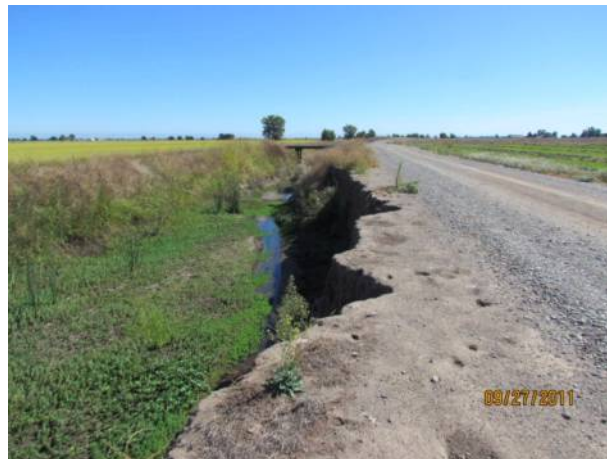
Levee Mile Report Line	5
Start Levee Mile	1.67
End Levee Mile	1.67
Location	Water Side
Category	Channels
Item	Erosion / Bank Caving

View of the erosion along the channel.

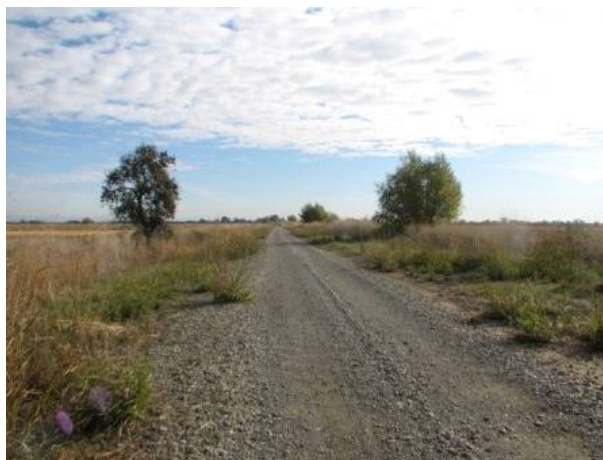
Levee Mile Report Line	1
Start Levee Mile	0.55
End Levee Mile	1.55
Location	Land Side
Category	Earthen Levee
Item	Vegetation

View of the grasses and vegetation on both slopes.

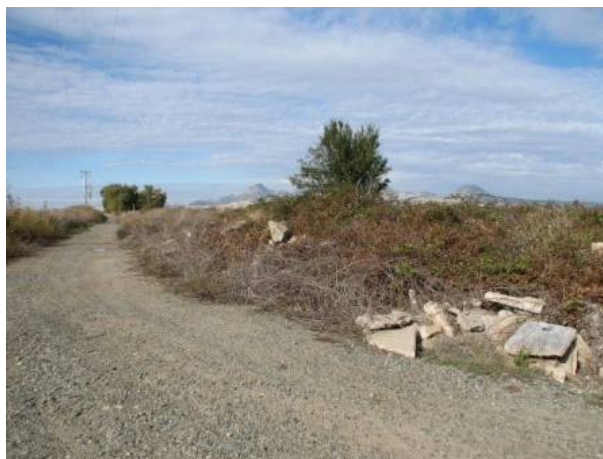
Levee Mile Report Line	3
Start Levee Mile	1.43
End Levee Mile	1.55
Location	Land Side
Category	Earthen Levee
Item	Encroachments

View of the pile of broken concrete next to the levee.

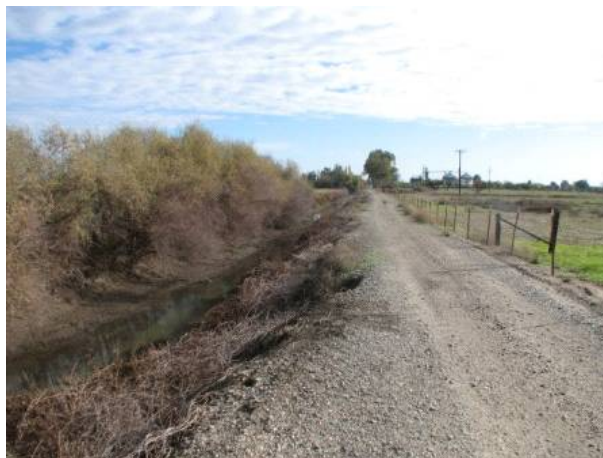
Levee Mile Report Line	4
Start Levee Mile	1.54
End Levee Mile	1.93
Location	Water Side
Category	Earthen Levee
Item	Erosion / Bank Caving

View of the erosion along the waterside slope.

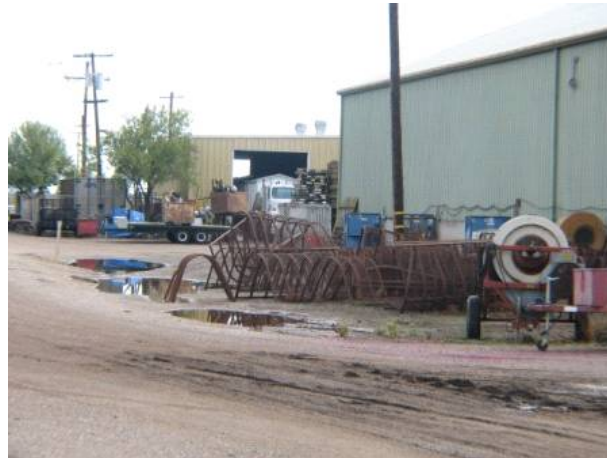
Levee Mile Report Line	5
Start Levee Mile	1.92
End Levee Mile	2.04
Location	Land Side
Category	Earthen Levee
Item	Encroachments
View of the equipment and buildings next to the landside berm.	
rduffey_f_20110927_504.jpg

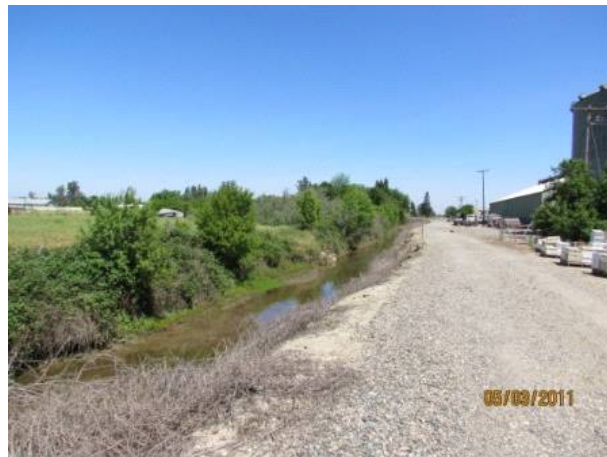
Levee Mile Report Line	6
Start Levee Mile	1.95
End Levee Mile	1.98
Location	Land Side
Category	Earthen Levee
Item	Erosion / Bank Caving
View of the erosion along the W/S slope.	
rduffey_f_20110927_505.jpg

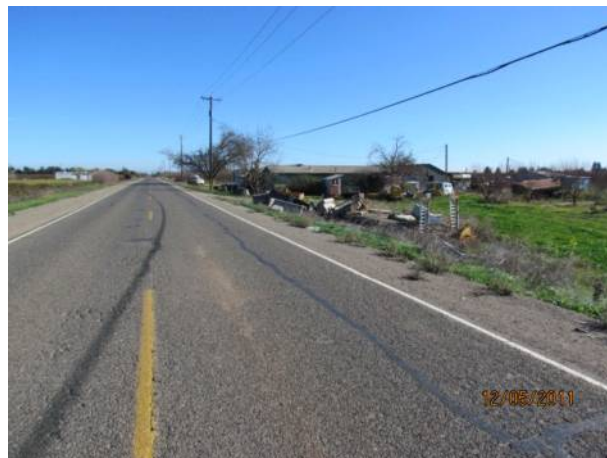
Levee Mile Report Line	7
Start Levee Mile	2.63
End Levee Mile	2.63
Location	Land Side
Category	Earthen Levee
Item	Encroachments
View of debris & garbage along the L/S toe.	
rduffey_f_20111206_561.jpg

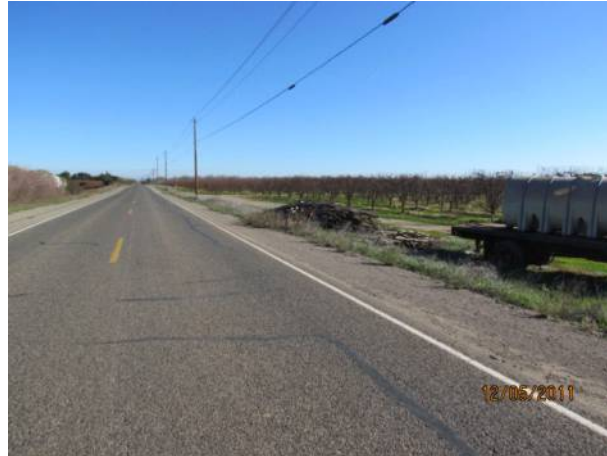
Levee Mile Report Line	8
Start Levee Mile	2.71
End Levee Mile	2.71
Location	Land Side
Category	Earthen Levee
Item	Encroachments
View of material, garbage & equipment along the L/S toe.	
rduffey_f_20111206_562.jpg
